Sealing of a Ring-Dam using Mixed-in-Place method

Dogern, Germany – 40 years ago, the Aubecken Reservoir in the river Rhine was put into operation next to the village of Dogern. Due to leaks in the ring dam of the pumped storage equalizing reservoir, the owner Schluchseewerk AG decided to overhaul it. BAUER Spezialtiefbau GmbH produced around 13,500 m² of cut-off wall using the Mixed-in-Place (MIP) technology in geotechnical demanding soil conditions over a length of 980 m. The method offered significant time and cost savings over alternative construction methods.

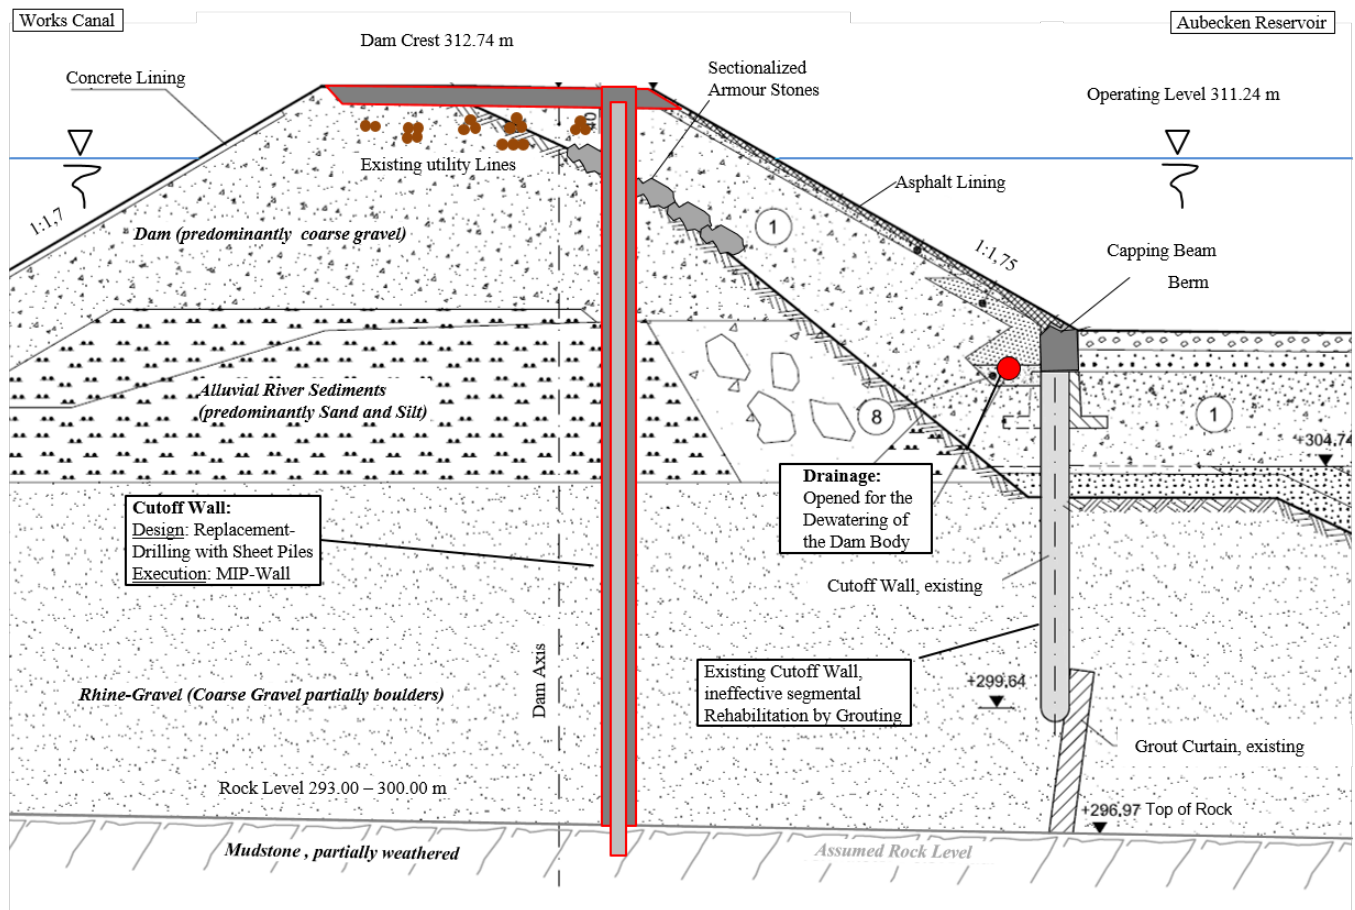
Standard cross-section remediation Aubecken (© RMD-Consult GmbH)
