Construction of the Plastic Concrete Cut-off Wall at Hinze Dam

Steve O'Brien¹, Christopher Dann², Gavan Hunter³, Mike Schwermer⁴

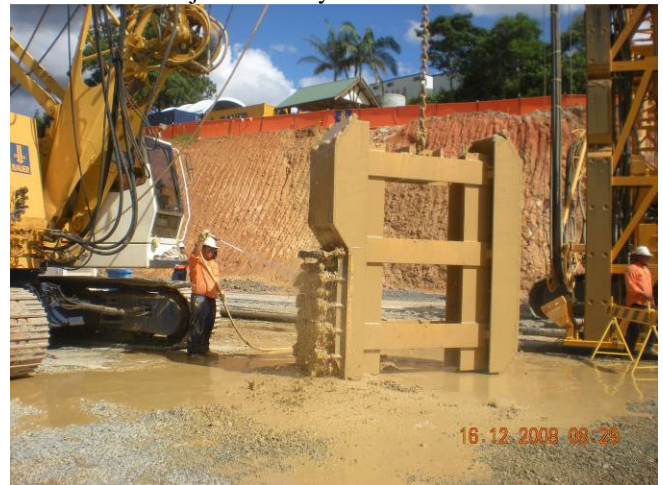
Plate 5 – Cleaning Brush for Joints

This method proved to be very successful. A number of joints were exposed following completion of the wall, the quality of the joints meant that it was typically difficult to detect where the joint actually was.

- After completion of excavation of the panel, the majority of the working bentonite within the trench is replaced with a more viscous bentonite.
- The sides of the adjacent primary panels are cleaned using the brush shown in Plate 5. This device is slightly wider than the cutter so that the brushes scrape down the side of the panel. The brush is also pulled across by the crane to the side being cleaned to ensure the brushes are bearing on the side of the panel.
- The trench cutter is then sent back down the secondary panel to clean any material from the base of the panel and to replace the bentonite

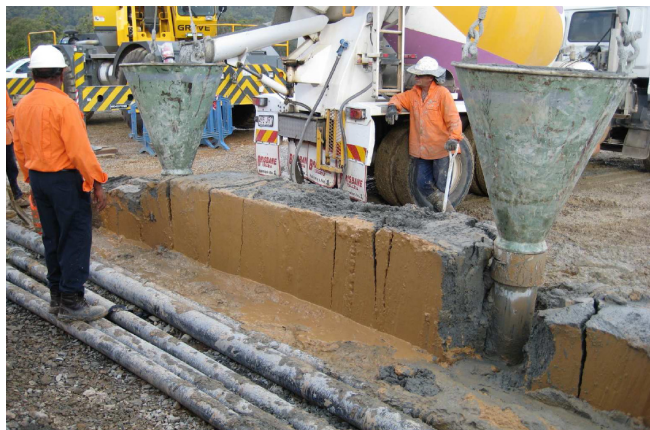
Plate 7 – Panel 25 Concrete Pour

During the pouring of the initial primary panels, it was observed that the concrete at the top of the panel appeared cohesive, see Plate 7, and was extruded up between the guidewalls. At times this meant the concrete could not be pushed out of the top of the panel or pushed out over the full width of the panel. Investigations and testing into the reasons for the cohesive concrete included the following:

To ensure that there were no joints or defects in the cohesive concrete, the top 5 to 6m of each of the secondary panels was excavated by the grab without the use of bentonite. This meant that the sides of each of the primary panels could be visually inspected. A couple of minor joint defects were found in the top portion of two of the panels. However as the top 1.5m of the wall was to be removed prior to construction of the overlying embankment, the defects would be removed.

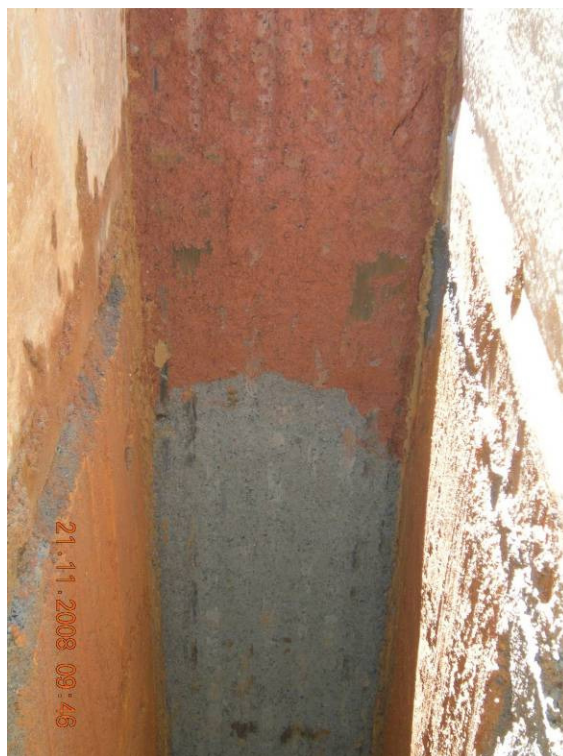
Plate 8 – Dye testing of concrete

It was determined that it was the concrete from the initial trucks that gets pushed to the surface of the panel. This effect can be seen in Plate 8 where the red dyed concrete from the initial trucks is clearly apparent above the later non dyed concrete.

From further investigations it was determined that over the time it takes to pour an entire primary panel, typically 6 to 8 hours, the concrete was going through its initial set and therefore appeared to be cohesive/stiff at the surface of the panel. The testing of the cohesive concrete and observations made gave no suggestions that there were any adverse effects to the concrete. The main concern was that the concrete extends to the full width and length of the panel to fill in any voids, particularly for the secondary panels.

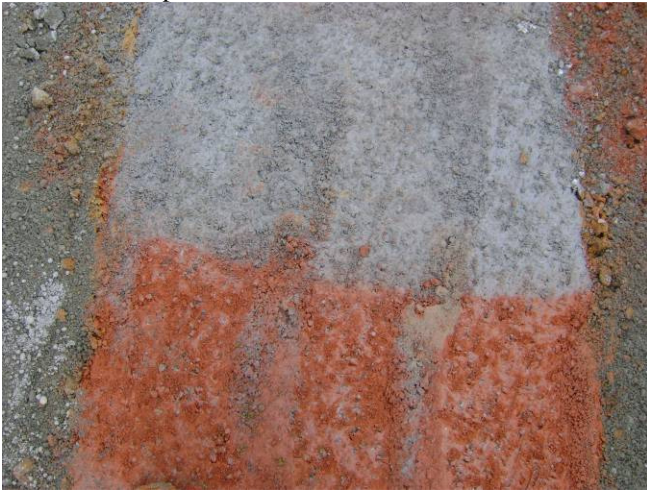
Plate 9 – View of joint between primary and secondary panels

inspection of the joints within the wall. It was typically difficult to detect the position of the joint which indicated that the cleaning process was effective in removing any excess bentonite. The quality of the joints can be seen in Plate 9 which shows the joint between a panel with dyed concrete and a panel without.

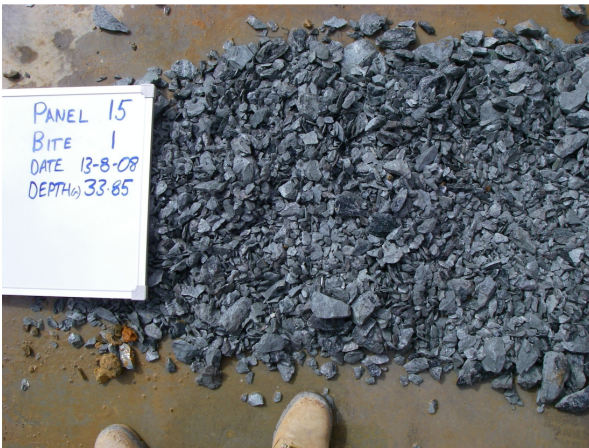
Plate 10 – Typical sample in slightly weathered to fresh greenstone

A critical aspect of the construction of the COW was ensuring that the base of the wall was sufficiently socketed into slightly weathered to fresh greenstone or greywacke to ensure no seepage paths could develop beneath the wall. The arrangement of the desanding plant was such that samples could be taken by placing an excavator bucket beneath the discharge point for the larger cuttings. This gave large high quality samples for assessment as shown in Plate 10. Once the samples were observed by the HDA geologist to have none or minimal traces of weathering in the rock then the excavation would continue for an additional 0.5m to ensure the panel was socketed into rock.
