A PERMANENT CONCRETE CUT-OFF WALL FOR THE BAGATELLE DAM, MAURITIUS – CHALLENGES AND LESSONS LEARNED

P Banzhaf¹, K Beckhaus¹, M Baltruschat¹

1. Bauer Spezialtiefbau GmbH, Schrobenhausen, Germany

ABSTRACT

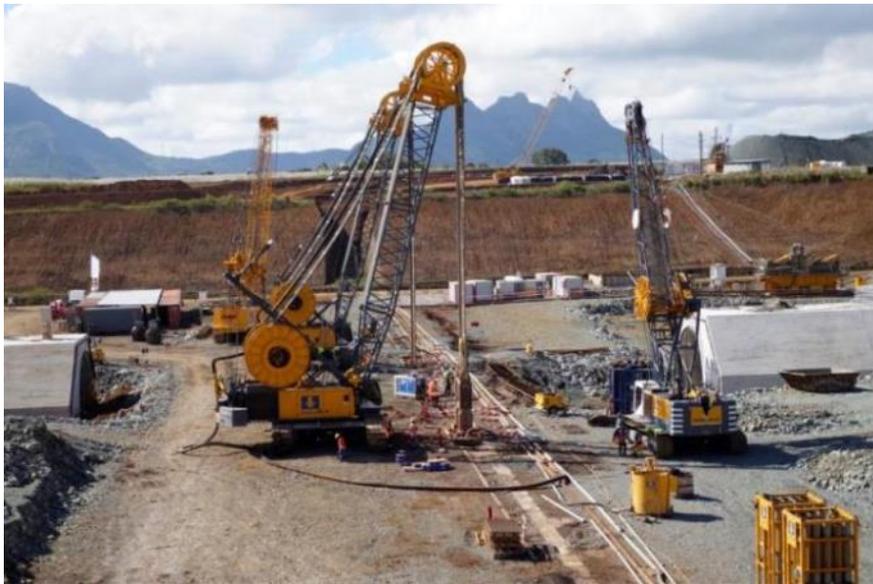
Figure 1 BAUER Trench-Cutter and Grabs along the CCOW installation

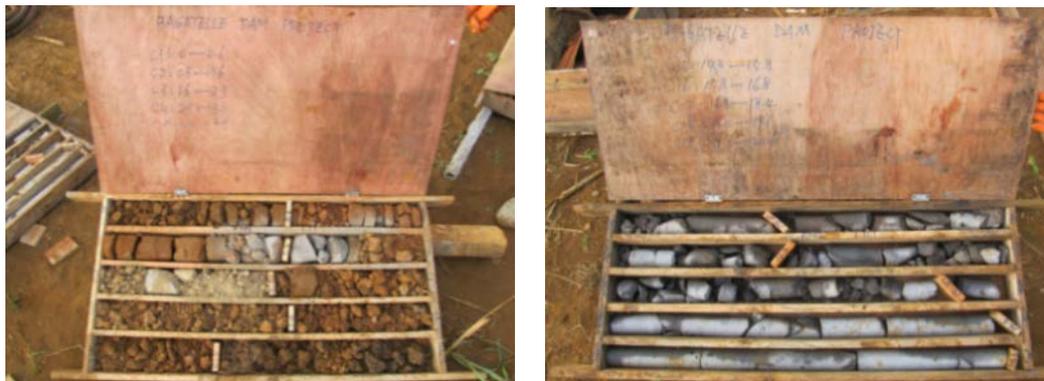
Figure 2 Core boxes showing weathered basalt with some cobbles (left) and fresh competent basalt (right)

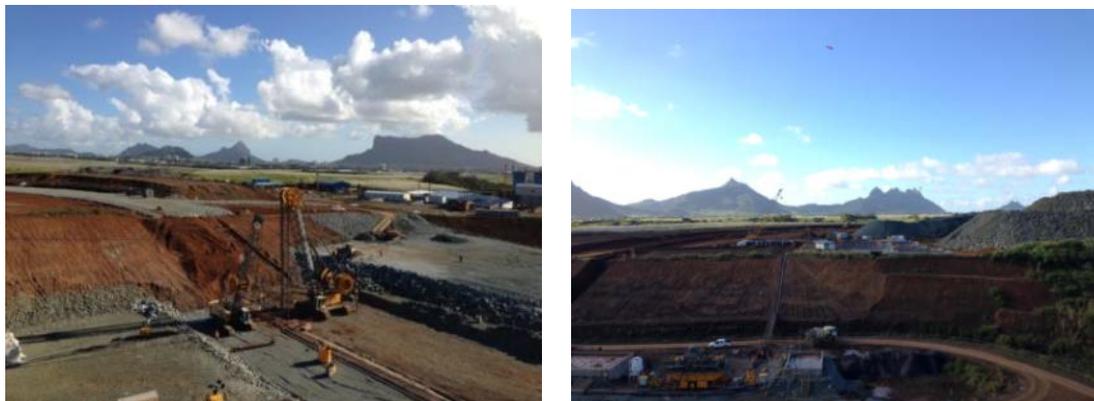
Figure 10 Changes in elevation Central Part to Left and Right Banks

At the Central Part the working platform elevation was at EL 360 m whereas the platform at the adjacent Left Bank was at approx. EL 372 m and at the Right Bank at approx. EL 375 m.
