Cut-off wall construction

A new diaphragm cut-off wall has been constructed for the Rosshaupten Dam in Germany.

Report by **Stefan Jaeger**, Tender Engineer at BAUER Spezialtiefbau GmbH

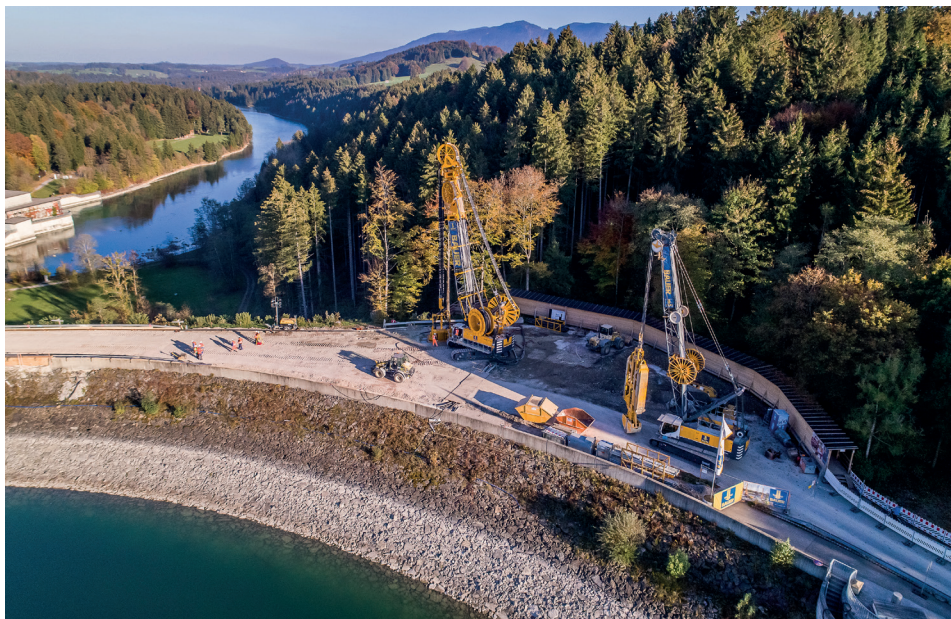
Right: **Figure 1: Rosshaupten Dam during remediation**

WITH A SURFACE AREA of approximately 16km², the Förgensee in the Allgäu region is the fifth largest lake in Bavaria and the largest reservoir in Germany in terms of surface area. The structure has been in operation since 1954. In autumn and winter, the lake releases water to the Lech river. In spring, it absorbs the water from melting snow and prevents flooding. To prepare the Rosshaupten Dam for the future, the power plant operator Uniper Kraftwerke GmbH commissioned BAUER Spezialtiefbau GmbH to renovate the inner seal of the dam (Figure 1).

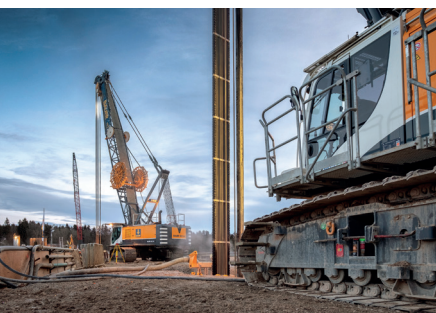
Below from left to right:
Figure 2: Excavation of the trench with the supporting effect of a slurry made of bentonite and water

During execution, the trench was excavated with the supporting effect of a slurry made of bentonite and water (Figure 2). Then the slurry-stabilized trench was filled with the diaphragm wall building material from bottom to top in the contractor method. In the process, the stabilizing slurry was displaced upward and pumped away. Element by element, this resulted in a new internal seal made of so-called clay concrete or soil concrete often also known as plastic concrete.

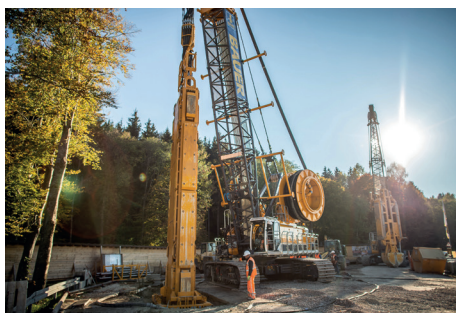
Figure 3: Two Bauer duty-cycle cranes of the types MC 96 (left) and MC 64 were used

The cut-off wall was executed in single-trench elements (Figure 3). At 3.2m, the length of each single trench corresponded to the width of the diaphragm walling grab and the trench cutter. To connect the individual trenches to a wall, the back-step method was applied. Two independent methods for surveying the trench during the excavation were used, which monitor each other. Inclometers were installed both in the grab and in the trench cutter, which indicated initial reference points for the verticality deviation of the excavation tools. In addition, the CIS (Cutter Indication System) and GIS (Grab Inclination System) systems, developed by Bauer, were used. The inclination of the wire ropes to which the grab or cutter were attached provided information about their exact position in the trench. A tachymeter recorded the position of the aboveground section of the wire ropes three-dimensionally in space (Figure 4). The top 40m of the dam from the crown to the contact area of the dam was excavated using a BAUER DHG hydraulically operated diaphragm walling grab. A BAUER MC 64 duty-cycle crane was used as base machine (Figure 5).

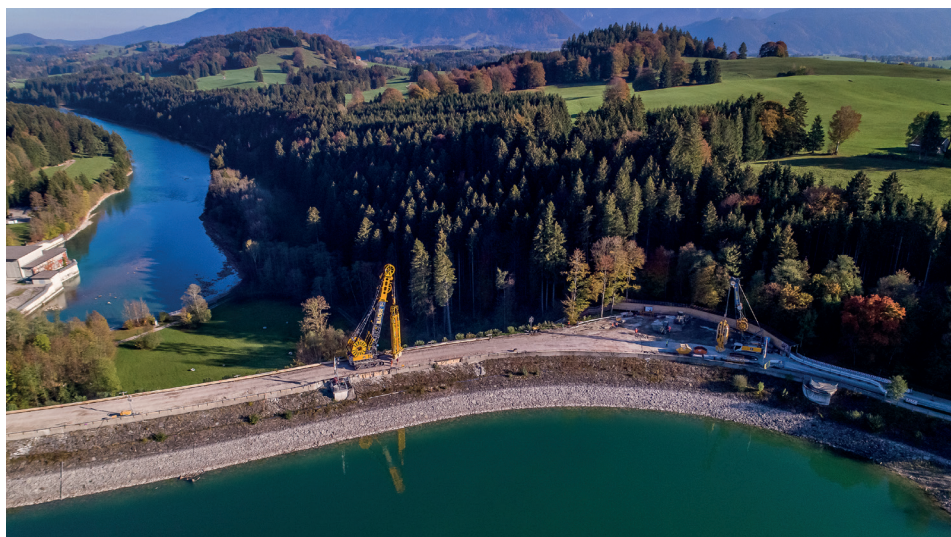
Below: Figure 8: View of the Rosshaupten Dam with its narrow dam crest

The special challenges in Rosshaupten were multifaceted: half of the diaphragm cut-off wall totalling 13,000m² in size had to be embedded in the rock (figure 6), whilst at the same time only a very narrow dam crest was available as a working area. In addition, the diaphragm wall is not in the middle of the narrow dam crest, but instead is located toward the upstream face. This resulted in the available working surface on the dam crest being substantially reduced so that the diaphragm wall rigs could not be positioned to ride over the trench. However, the cut-off wall was produced without widening the crown of the dam: the base machine, a BAUER MC 96 (Figure 7) duty-cycle crane was equipped with the turnable BAUER HDS-T hose drum system, so that the BC 40 trench cutter could be rotated on its own axis. This made it possible to align the cutter parallel to the undercarriage even when the upper carriage of the duty-cycle crane was only partially pivoted. The diaphragm wall could only be executed in this special rig position (Figure 8).

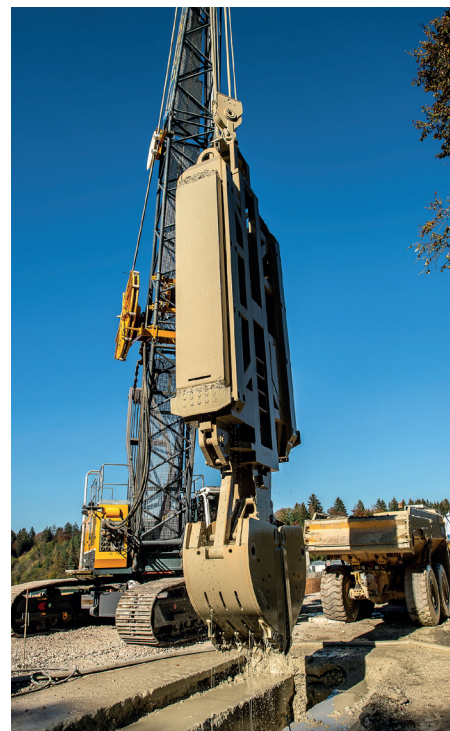
Figure 5: A BAUER MC 64 duty-cycle crane was used as a base machine for the hydraulic grab

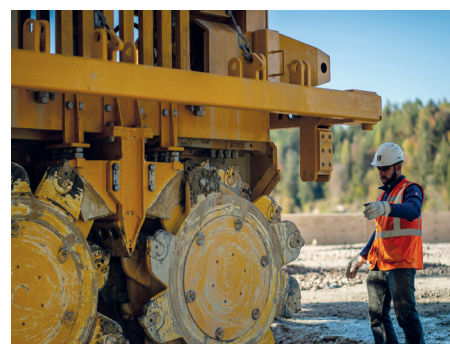
Figure 6: Approx. 6200m² of diaphragm cut-off wall was embedded in the bedrock using the trench cutter

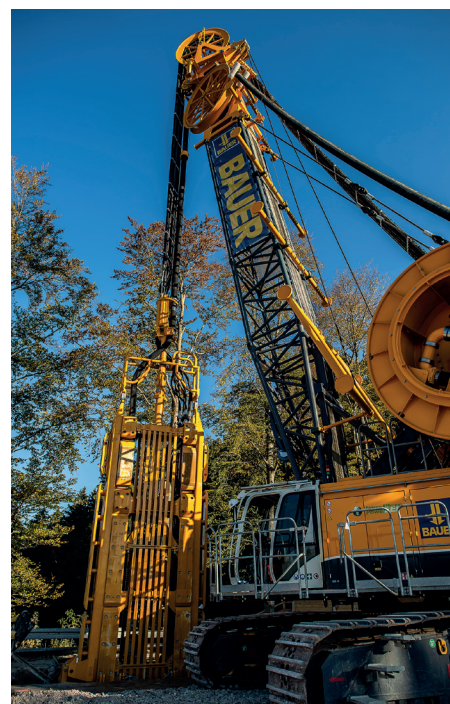
Figure 7: BAUER MC 96 base machine equipped with a turning device to rotate the BC 40 trench cutter on its own axis
