Durable Embankment Dam Rehabilitation by Concrete Cut-off Walls installed by Hydro Cutters – a safe and economical approach for a durable solution

Peter Banzhaf, Dipl.Eng., Head Dam Services, BAUER Spezialtiefbau, Schrobenhausen, Bavaria, Germany
Et al.

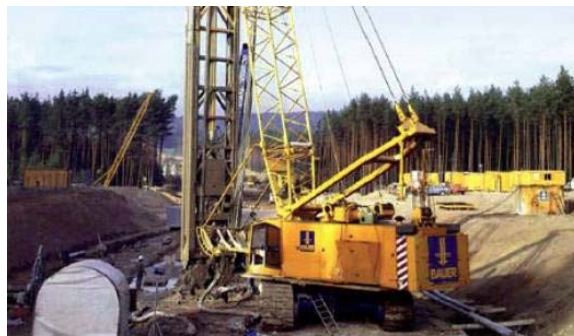
Figure 2. Trench Cutter at Brombach Main Dam, Germany 1984

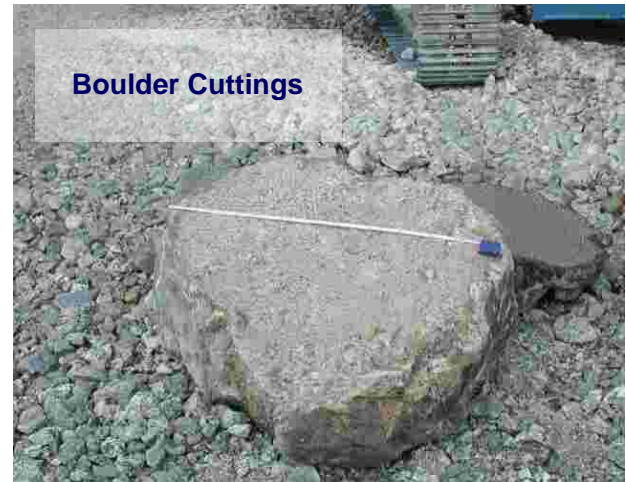
Figure 4. Cutting of cobbles and boulders

Apart from the wall depth, the strength of the rock, in which the design of wall asked for embedment, was the challenge. The capacity of the base machines to provide hydraulic power was improved to carry heavier cutters and to provide more power to the gearboxes of the cutter wheels. Whereas in the nineties rock strengths of 100 MPa unconfined compressive strength (UCS) was almost the limit for the available cutters, hard rock with UCS of more than 150MPa is being cut by these equipment's since beginning of the new millennium. Ways to successfully and effectively treat and cut cobbles and boulders was developed by BAUER in the last 10 years.

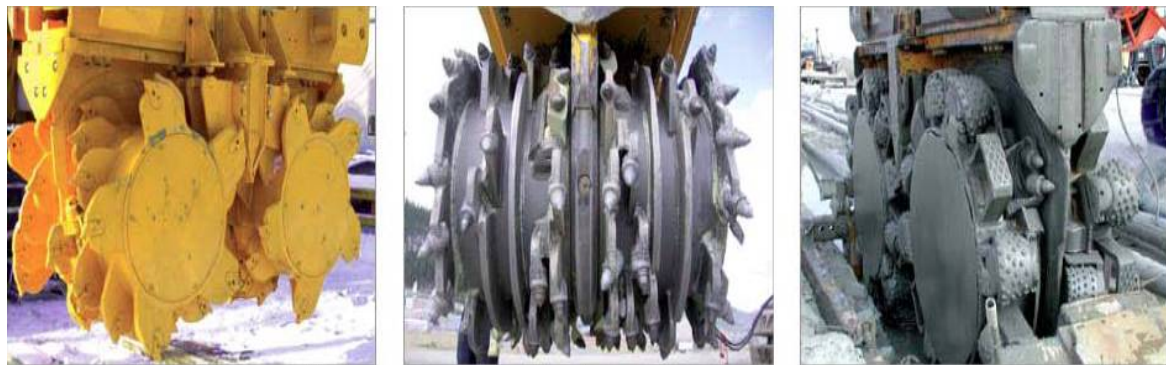
Figure 6. Wheel-sets (BAUER) for rock-cutting (soft-medium-hard)

With innovative developments over the past 15 years the equipment available is cutting rock with unconfined compressive strengths of 180 MPa and more. The installed power permits rock cutting under a cutter weight of more than 50 tons. Rock cutting wheel-sets have been developed for medium to very hard rock.

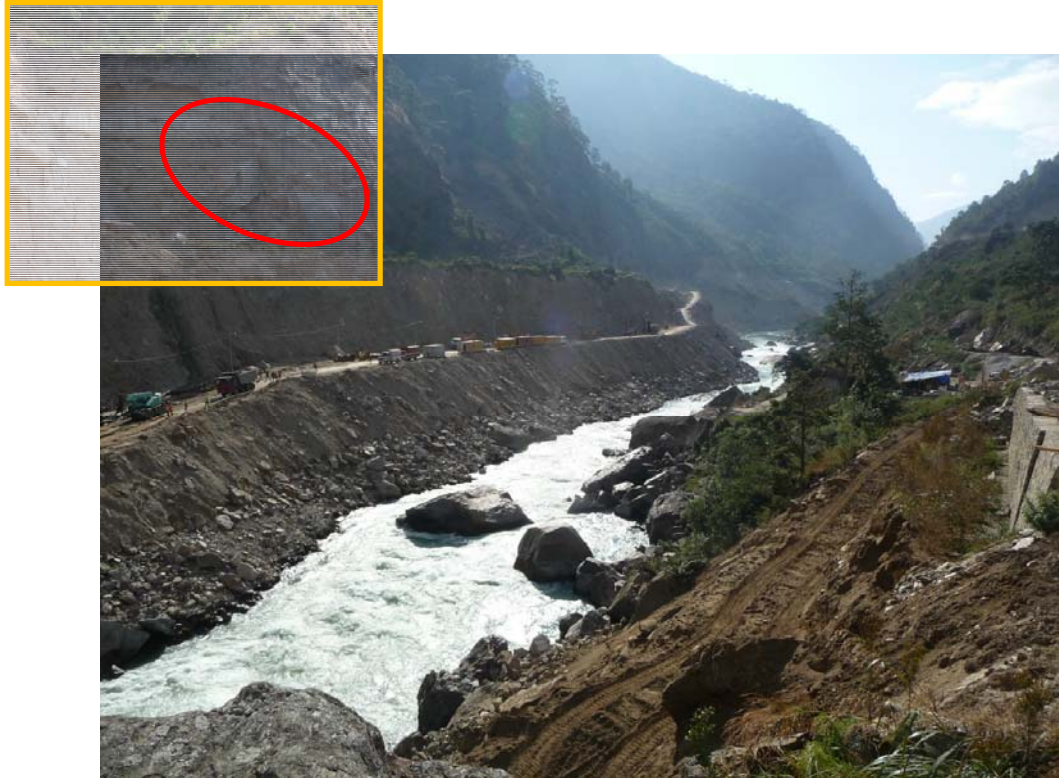
Figure 7. Boulders at Punatsangchhu, Bhutan

Installation cut-off walls in mountainous valleys often ask for treatment and cutting of cobbles and boulders. With the experiences from the Dhauliganga Hydro Electric Power project (HEP) and the Peribonka HEP cut-off wall installation in such valleys or even gorges with overhangs and cliffs is now experience-wise and equipment-technological-wise possible.

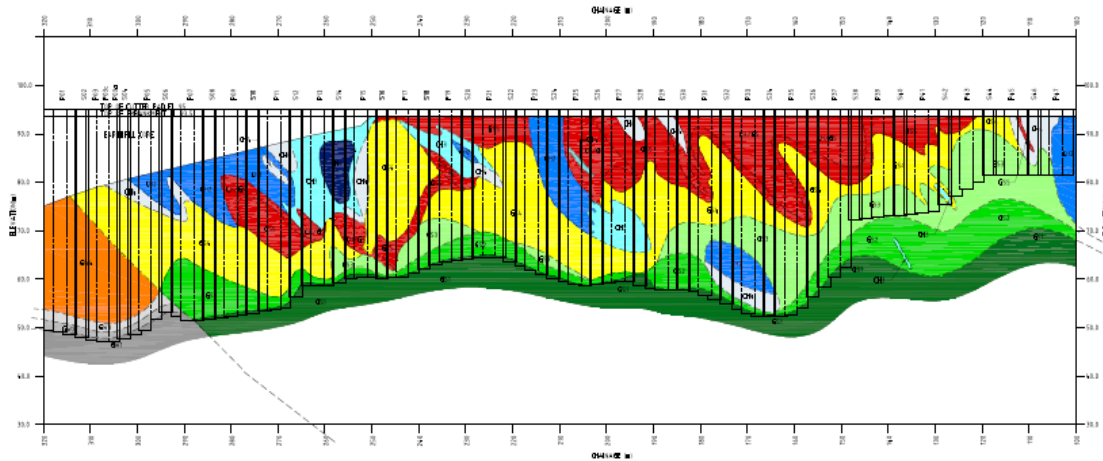
Figure 9. Hinze dam, Australia - geological profile and panel layout at the right abutment (see legend below)

- Basalt/Greenstone – **extremely weathered** to **fresh**
- Greywacke – **extremely weathered** to **fresh**
- Chert – **weathered** to **extremely high strength**

Not only are boulders and cobbles challenging for execution and for the equipment, similarly are complex geologies with fresh rock and adjacent completely weathered rock in the area of a cut-off wall. The example of the Hinze Dam Project, Australia shows such demanding geological conditions. After proper design and planning, the wall was executed successfully by skilled and well trained staff. Refer also to the paper of Steve O'Brien et al CONSTRUCTION OF THE PLASTIC CONCRETE CUT-OFF WALL AT HINZE DAM .

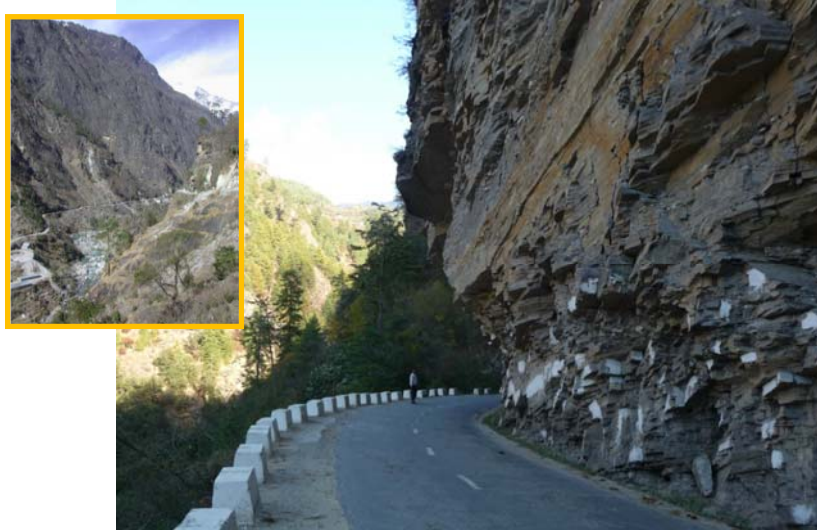
Figure 11. Challenging transportation routes for heavy equipment – Himalaya

The modular character of the main equipment allows access to remote areas, whether it is via small winding roads in the Himalayas or via ice-roads to the Diavik project in northern Canada.

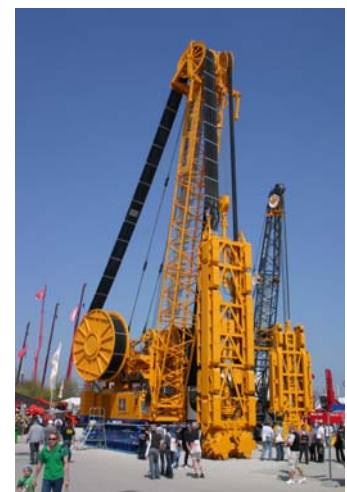
Figure 13. Trench Cutter at BAUMA exhibition, Munich 2010

At the BAUMA 2010, Munich the next generation of trench cutter was exhibited, the BAUER Trench Cutter HDS 150 on MC128 with excavation depths of 150m and designed for excavations well beyond this depths.

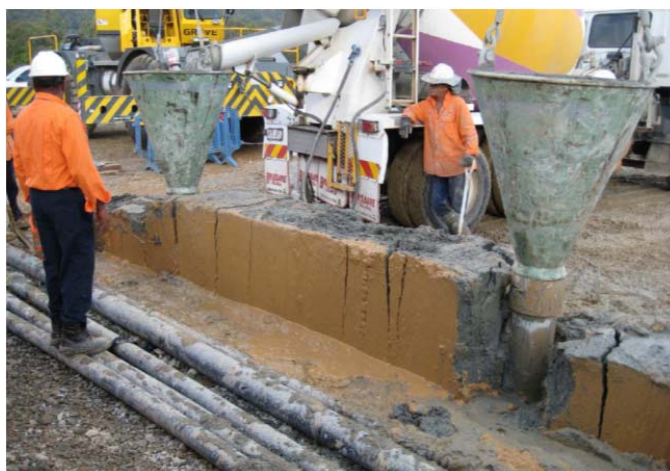
Figure 15. Up-rising cohesive plastic concrete

Although the plastic concrete was produced using a retarding agent at a lab-tested dosage supposed to ensure slump retardation of several hours, the plastic concrete poured at the very beginning had initially started setting before having risen to the surface.

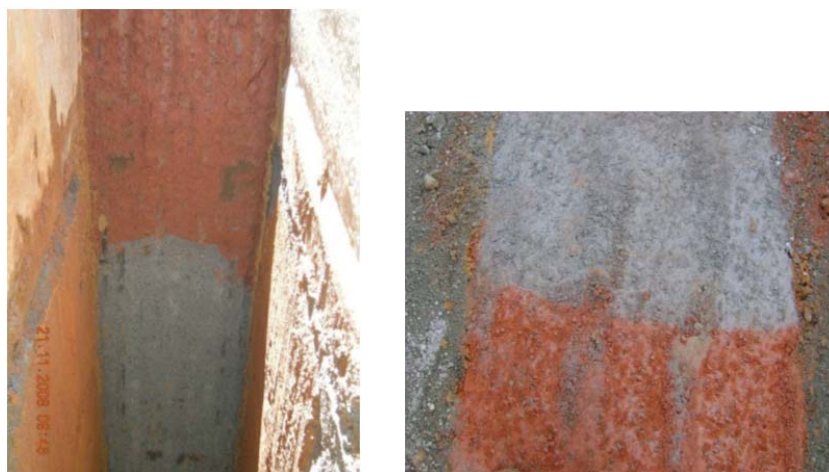
Figure 17. Dyed concrete for testing and confirmation of assumptions. Perfect quality of joints was proven.

Primary panels already installed with early setting concrete were proven to be of proper quality by investigating intensively before pouring the secondary panels.

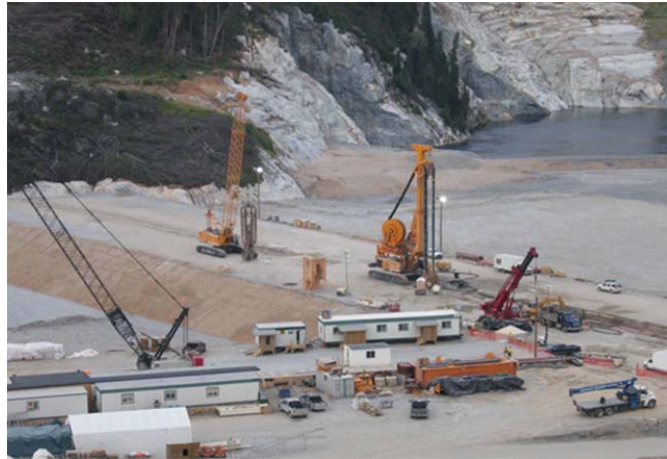
Figure 18. Set-up for cut-off wall at Peribonka dam, Canada

Owner Hydro-Quebec and designer SNC-Lavalin faced problems with water seepage at the 80-m-high dam along the Peribonka River in Québec, Canada. The successfully completed plastic concrete cut-off wall with the exceptional depth of up to 116 m was the solution, but stretched the limits of at the time possible geotechnical construction techniques.

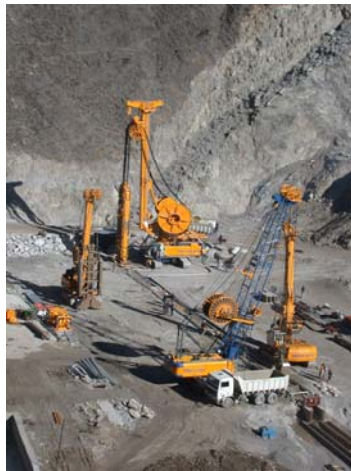
Figure 21. Site set-up for cut-off wall at Dhaulingana-1, India

The 7,500 m² plastic concrete cut-off wall of 1,000 mm thickness has a depth of up to 75 m and is embedded into the granite and gneiss bedrock. The works have been executed with a BAUER cutter BC40 in 2003.

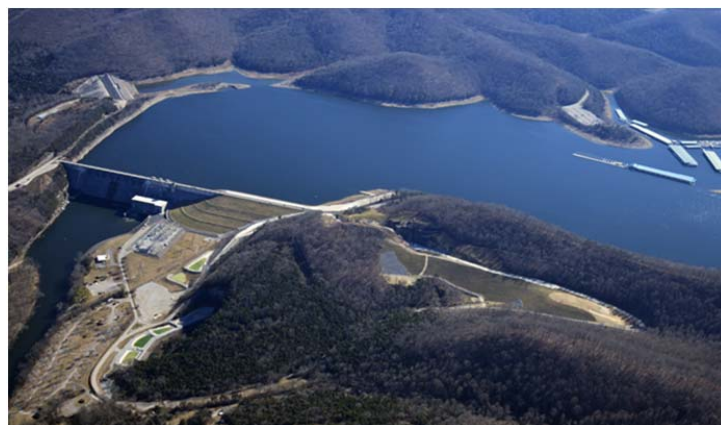
Figure 22. Center Hill Dam - aerial view

A concrete cut-off wall will be built within the entire length of the embankment dam. The wall will extend up to 95 m depth into the limestone foundation to cut off seepage and stop erosion. The USACE design asks for an encasement wall with a thickness of 2.25 m in the upper part and a barrier wall 800 mm into the lower part and final depth.

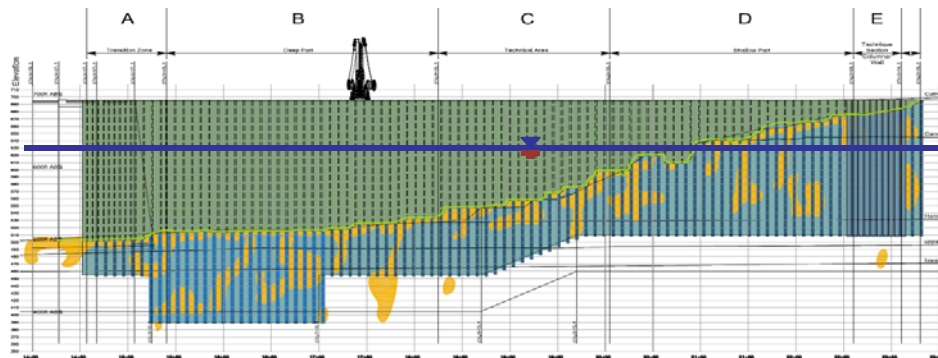
Figure 23. Center Hill Dam - barrier wall
