Sealing of a Ring-Dam using Mixed-in-Place method

Dogern, Germany – 40 years ago, the Aubecken Reservoir in the river Rhine was put into operation next to the village of Dogern. Due to leaks in the ring dam of the pumped storage equalizing reservoir, the owner Schluchseewerk AG decided to overhaul it. BAUER Spezialtiefbau GmbH produced around 13,500 m² of cut-off wall using the Mixed-in-Place (MIP) technology in geotechnical demanding soil conditions over a length of 980 m. The method offered significant time and cost savings over alternative construction methods.

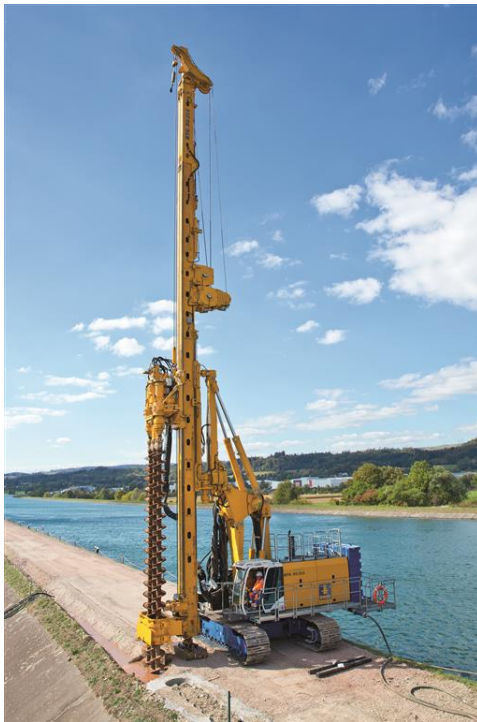
Production of the Mixed-in-Place wall by means of an RG 25 with triple auger (© BAUER Group)

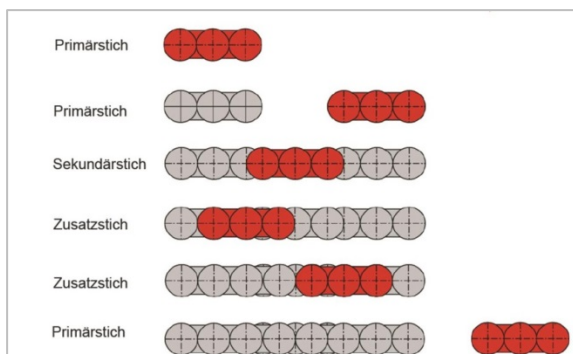
To ensure a continuous, jointless wall, the MIP walls were constructed in a double back-step method, which ensures that each wall element is passed through and mixed at least twice by the triple auger.

Manufacturing sequence "double pilgrim step" in the Mixed-in-Place method (© BAUER Group)
