Cut-off Wall for the Strengthening of the Sylvenstein Reservoir (70 km south of Munich, Germany) Cut-off Wall executed with BAUER cutter & grab and Plastic Concrete

**Dipl.-Geol. Michael Baltruschat; Dipl.-Ing. Peter Banzhaf;
Dipl.-Ing. Sebastian Beutler; Dipl.-Ing. Stefan Hechendorfer**
BAUER Spezialtiefbau GmbH
BAUER-Str. 1,
86529 Schrobenhausen
Germany

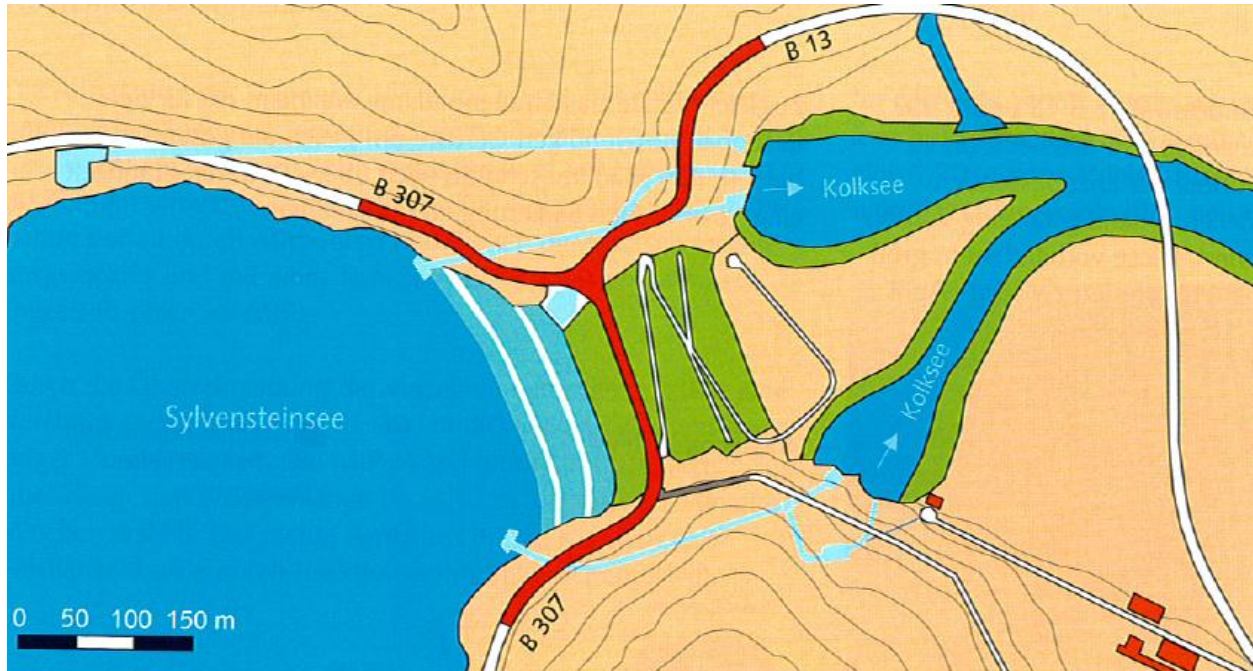
Fig. 1: Overview Sylvenstein Dam and adjacent roads (Source: WWA-WM)

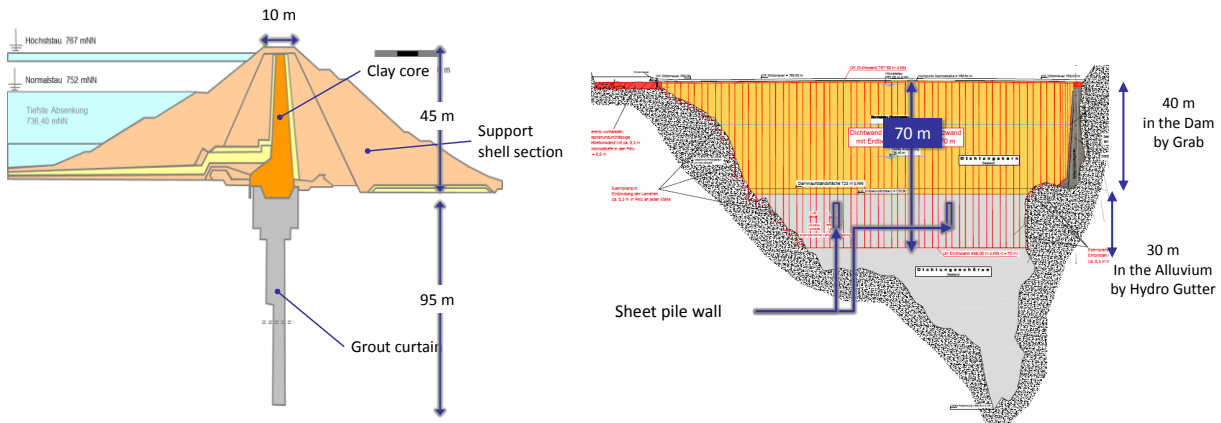
Fig. 2: Sections showing the Sylvenstein Dam prior to COW installation and planned COW (Source: WWA-WM)

The refit-design asked for a new sealing element by means of a 2-phase cut-off wall which had to be constructed offset to the core of the dam slightly towards the downstream side and had to key in to the steep rock flanks. The depth of the cut-off wall has been determined based on reconnaissance drillings performed down to 140 m deep in the substratum of the dam.

Due to imbedded layers of gravel and rock sediments and to the fluctuating permeability in the bottom sealing, the cut-off wall had to be extended down to 70m below the dam crest (suffusion stability).

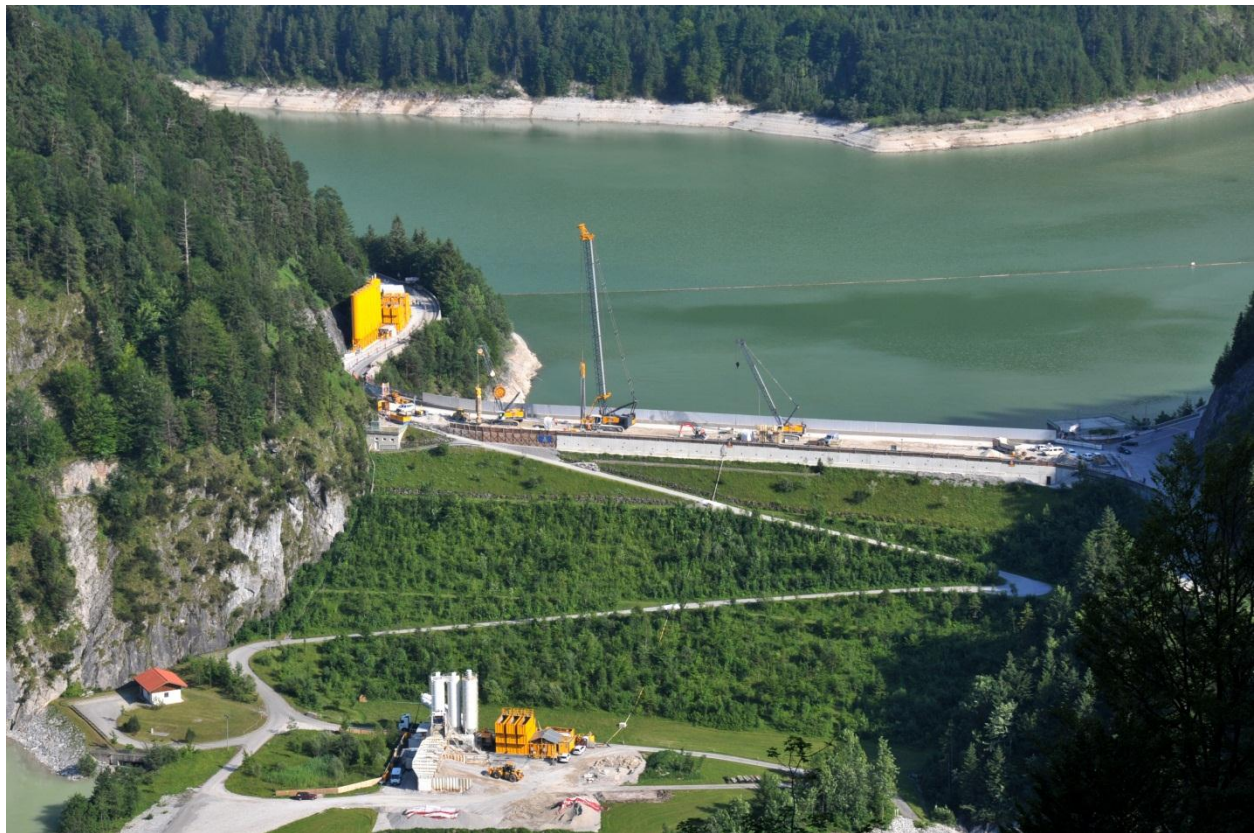
Fig. 3: Sylvenstein Dam – view from downstream – COW under execution.

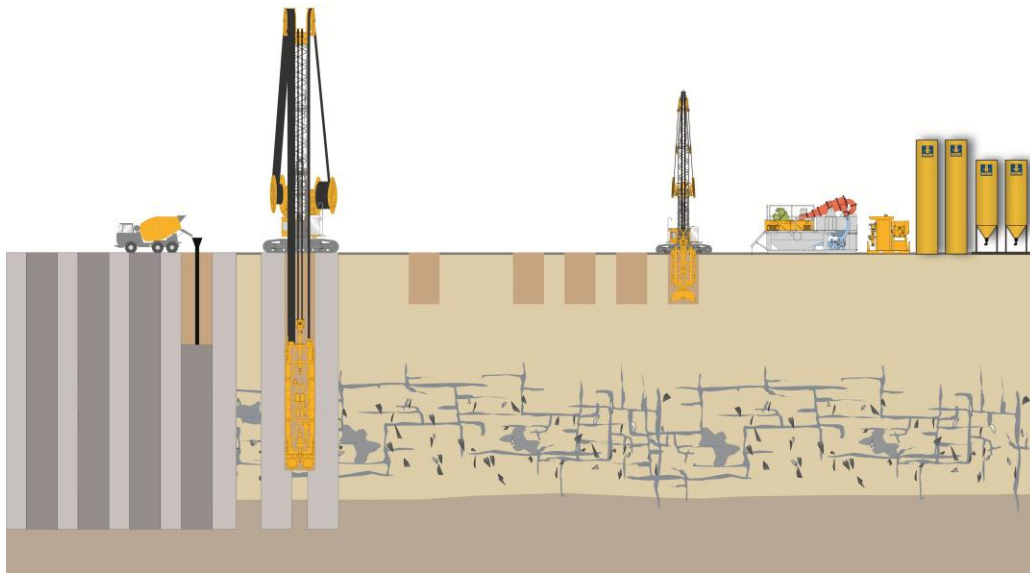
Fig. 4: Typical Method and Equipment Technology

The individual panel-elements were excavated under slurry, using grab and hydrocutter. According to schedule, individual panels were pre-excavated with a hydraulic grab (Type BAUER DHG) to a depth of approx. 40 m (corresponds approximately to a level shortly above dam foundation level). Then the panels were completed to the specified depth of up to 70 m. At both abutments the full-face embedment into the rock was executed with the hydrocutter. The individual steps of the cut-off wall installation are shown in Fig. 4 and Fig. 6.

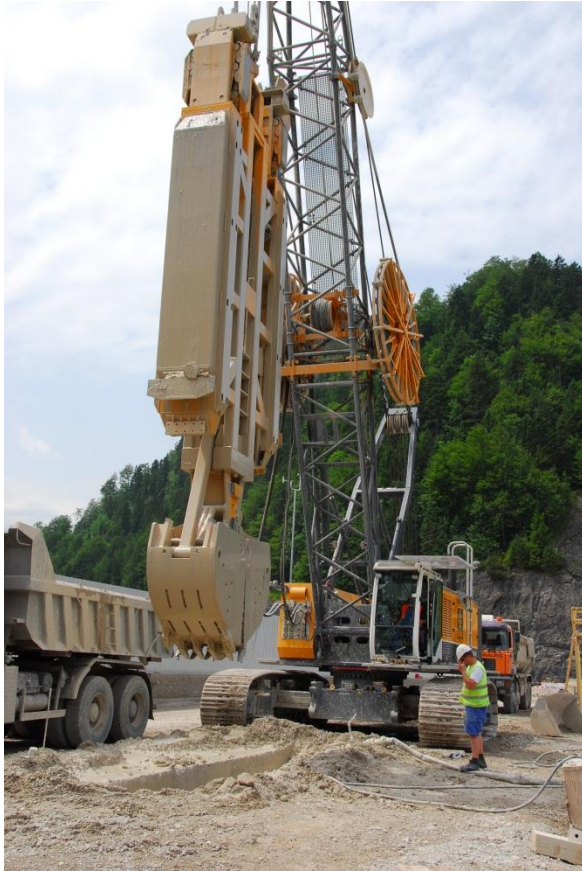
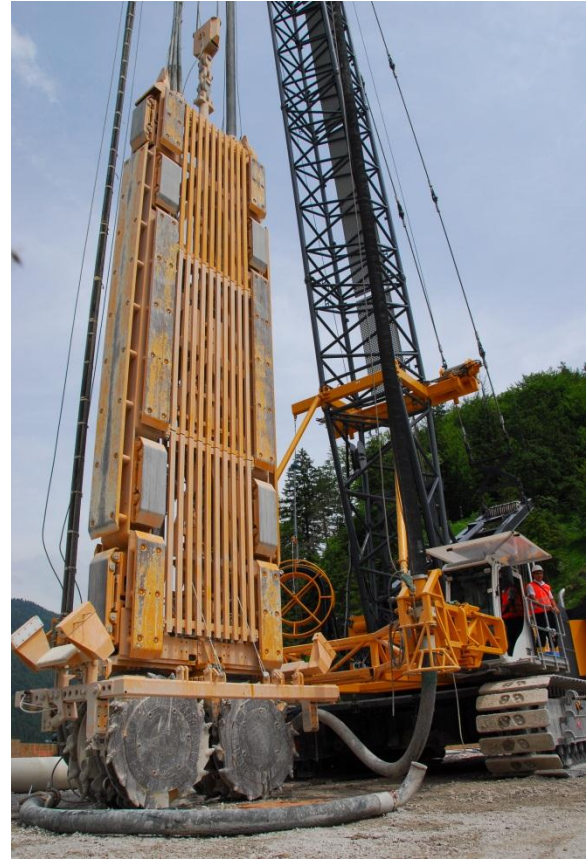
Fig. 5: The main equipment; left: BAUER MC 64 with hydraulic grab – right: BAUER MC 128 wit BC 40 Cutter

The 10,000 m² cut-off wall was constructed by Bauer Spezialtiefbau from dam crest which is stretching over 180 m; cutting of the trench was executed in its upper parts using a grab and continued to the final depth (70 m) by means of a BC40 cutter mounted on MC128 where the edges of the wall had to be embedded in very hard rock. Particularly challenging was the timely execution from a restricted working platform width.

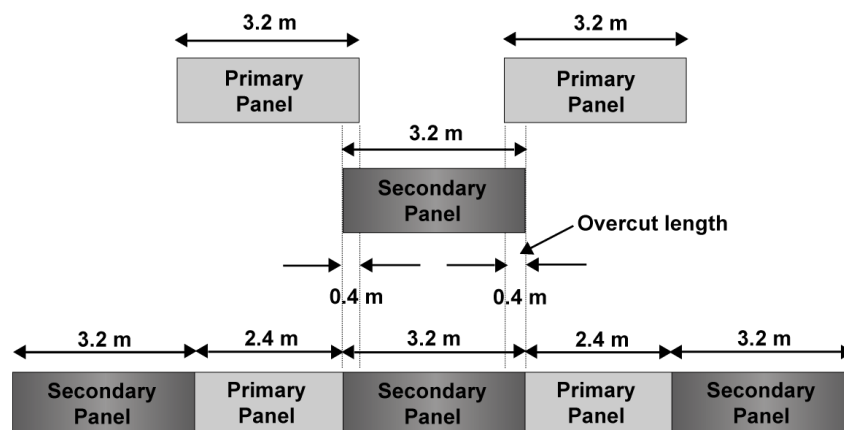
Fig. 6: Primary and Secondary Panel-layout; schematically.

Only individual panels with a dimension of 3.2 x 1.0 m (length x width) were constructed for the Sylvenstein project, typically for an impounded reservoir. The only exceptions are the panels at the final ends both in the west (area Hennenköpfl) and in the east (area Sylvenstein) of the COW. In the east there is an existing conical buttress. The peripheral panels had to be connected to this structure with individual special solutions.

The single panels were constructed in the so called pilgrim-step-method. The subsequently constructed secondary panels overlap with the adjacent primary panels by typically 40 cm each side.

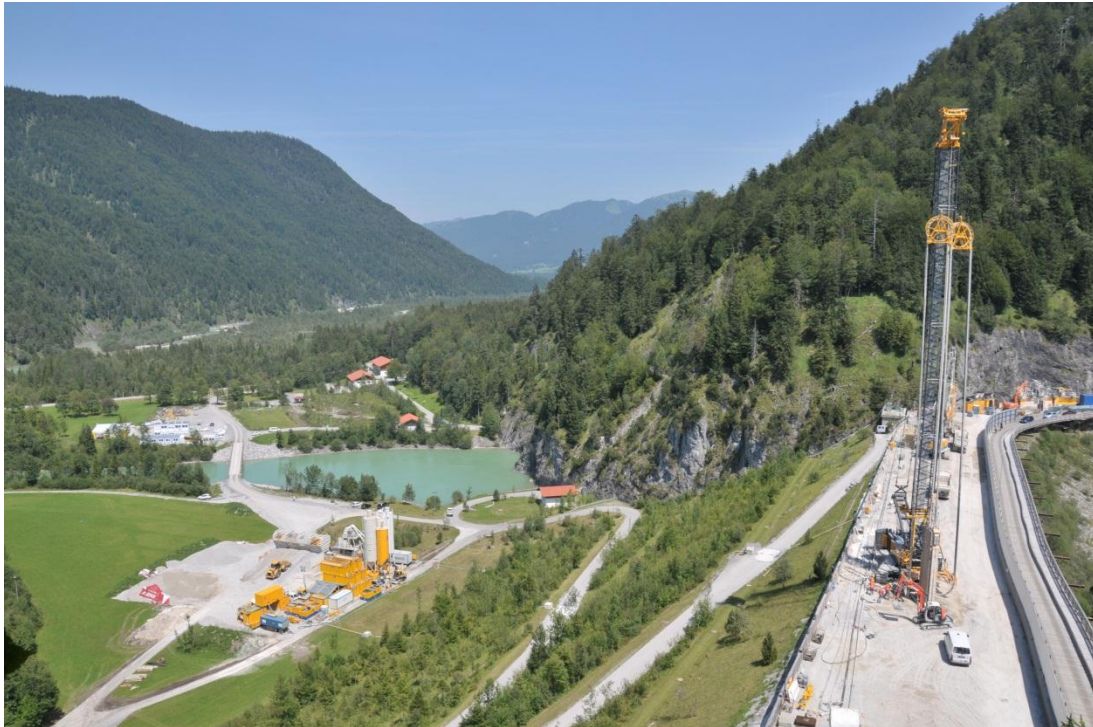
Fig. 7: Construction Tasks – narrow platform width and permanent traffic upstream along the platform

- Narrow working platform width (16.5 m) => longitudinal working position is necessary
- Extension of the existing main road with permanent concrete abutment and backfill material
- Maximum depth 70 m;
- Rock embedment: 30 cm at each location
- Connection to existing concrete structure (conical buttress);
- Old existing sheet piles in the COW-axis

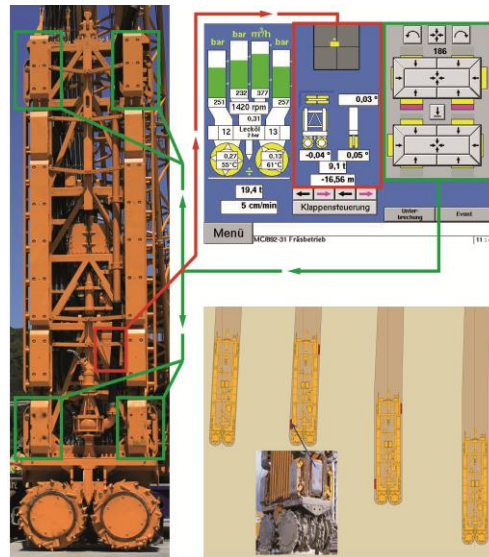
Fig. 8: Cutter Verticality Control

The data resulting from the inclinometer measuring unit (Fig. 8) were displayed in as-built drawings to check a sufficient overlapping, sections drawn to scale (two primary panels and the relevant secondary panels adjacent at both sides) were prepared. For the relevant final depth the primary panels were already marked in their relevant as-built position in these section drawings. After completion of the measurement for the secondary panel the site manager was able to mark its position in as-built drawings and assess prior to the concreting works if there was the necessary overlapping or remedial measures need to be taken. According to the Quality Management Plan (QMP) a sufficient overlapping rate had to be verified.

After completion, the as-built dimensions of the secondary panel were added to the in as-built drawings, thus a thorough CAD-plan about the complete wall was created.
